**U.S. ENVIRONMENTAL PROTECTION AGENCY
REGION III
CLEAN WATER ACT
COMPLIANCE INSPECTION REPORT**

Name of Facility: Super Salvage, Inc.
Facility Address: 1711 1st St SW Washington, DC 20024
Mailing Address: 1711 1st St SW Washington, DC 20024

Inspection Date: February 20, 2013
Entry Time: 1:40 pm EST
Exit Time: 3:30 pm EST

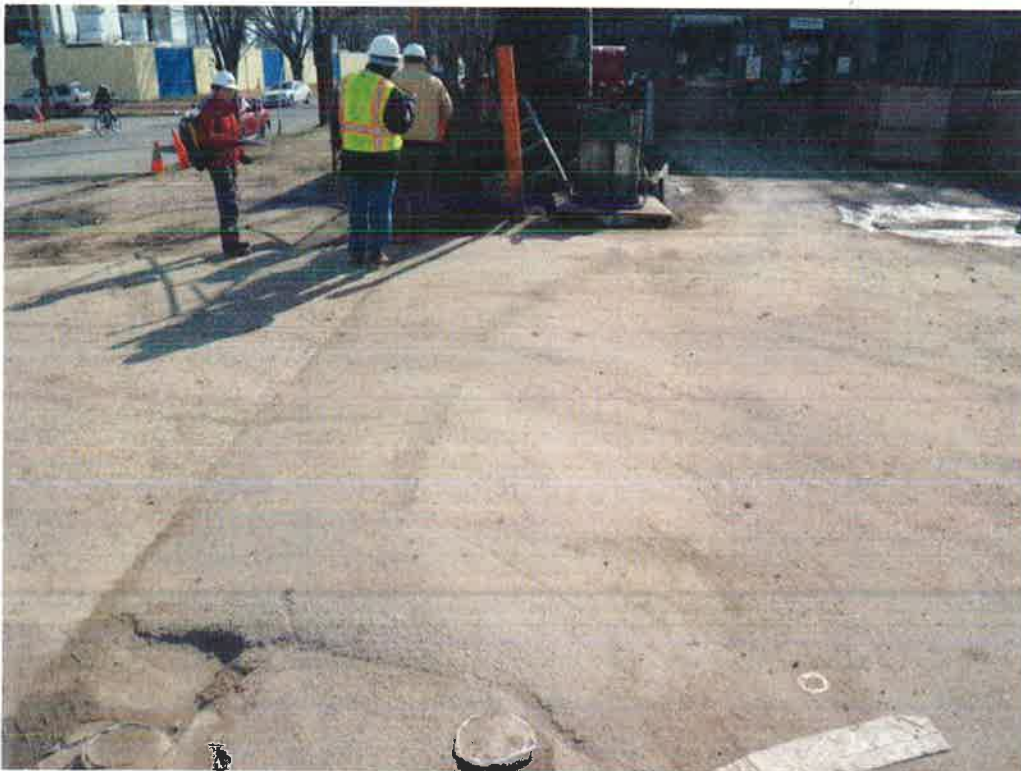
Photograph 2. Berm at Entrance 1 of the site.

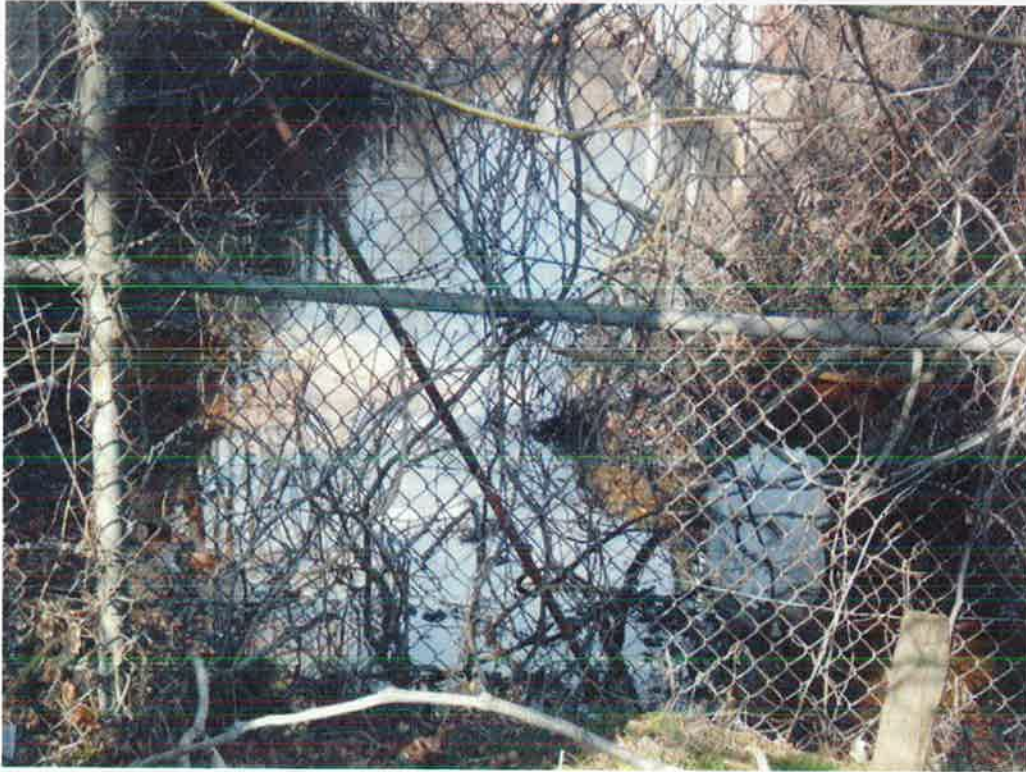
Observation 2: The EPA inspection team observed a number of spills and no active cleanup of those spills. The EPA inspection team observed what appeared to be oil and/or chemical layer floating on the surface of the large runoff collection pond. A saturated absorbent sock was observed adjacent to the pond (see Photographs 38-40 in Appendix B); however, the facility did not have active mitigation measures in place to remove the layer floating on top of the large collection pond. The EPA inspection team also observed vehicle air conditioning units placed on the ground and leaking fluids; however, no absorbent materials were placed on the leaking fluids (see Photographs 48-50 in Appendix B). The EPA inspection team observed what appeared to be oil staining outside of the perimeter berm (see Photographs 75 and 78 in Appendix B), sediment residue and liquids on District of Columbia (DC) streets outside/near entrance 2 (see Photographs 61 and 62 in Appendix B) and drainage from Super Salvage's open-top dumpsters located on, according to Mr. Bullock, DC property adjacent to the facility fence line (see Photographs 63 and 64 in Appendix B).

Photograph 5. Overall view of the large runoff collection pond.

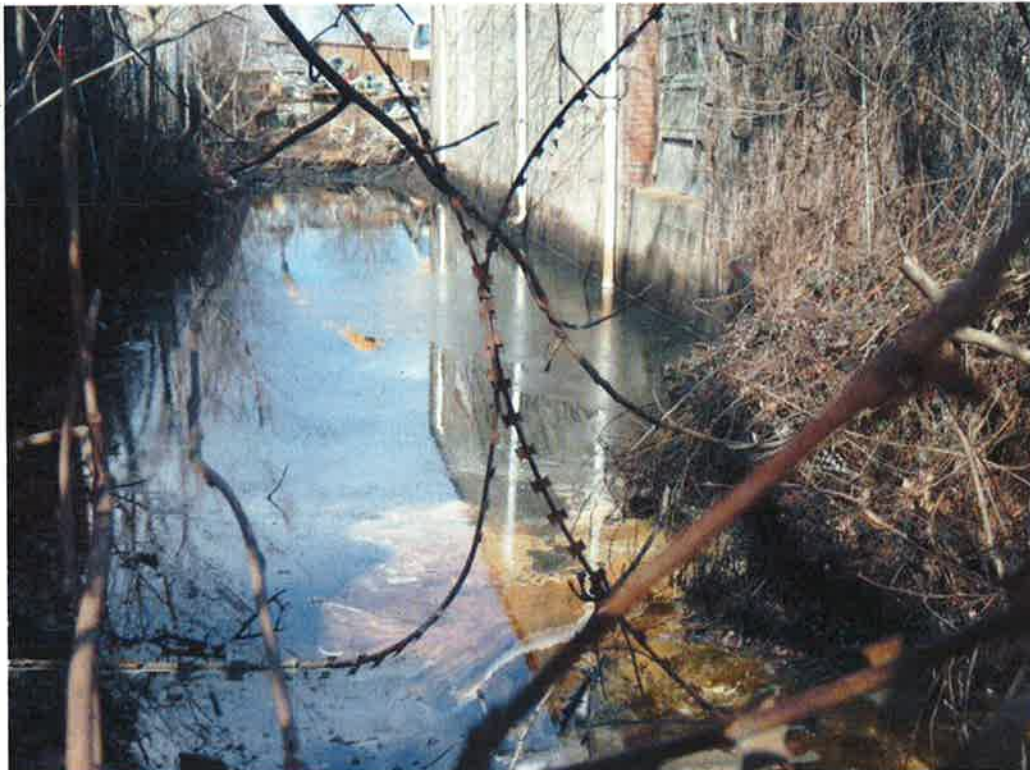
Photograph 12. The water elevation line height as indicated on side of the building.

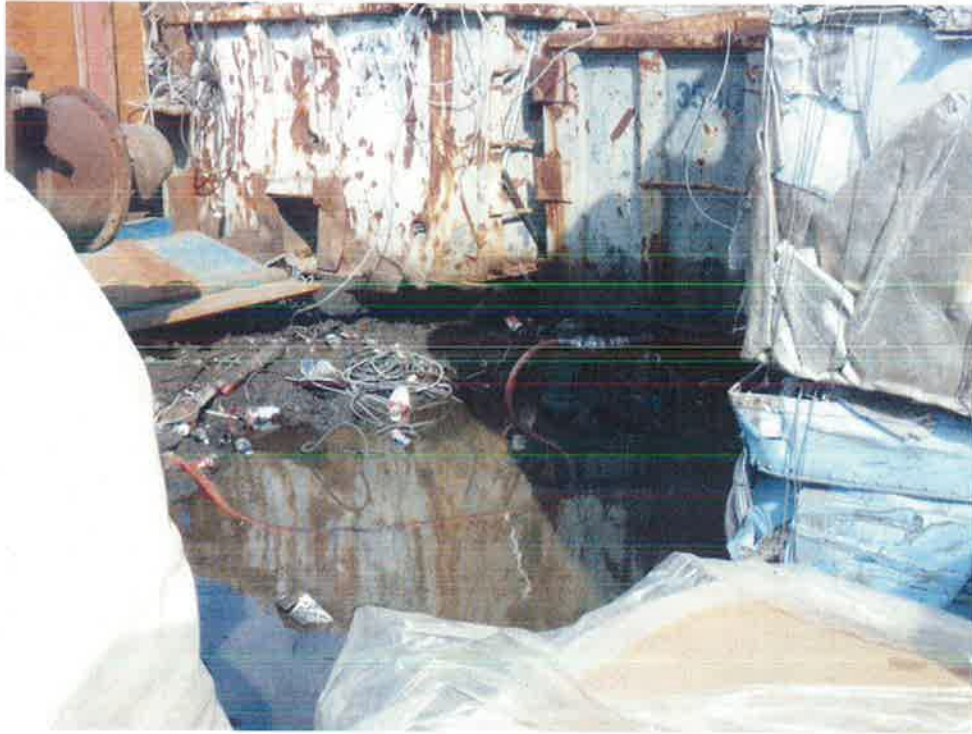
Photograph 13. Small runoff collection pond with a manual pump near the center of the scrap yard.

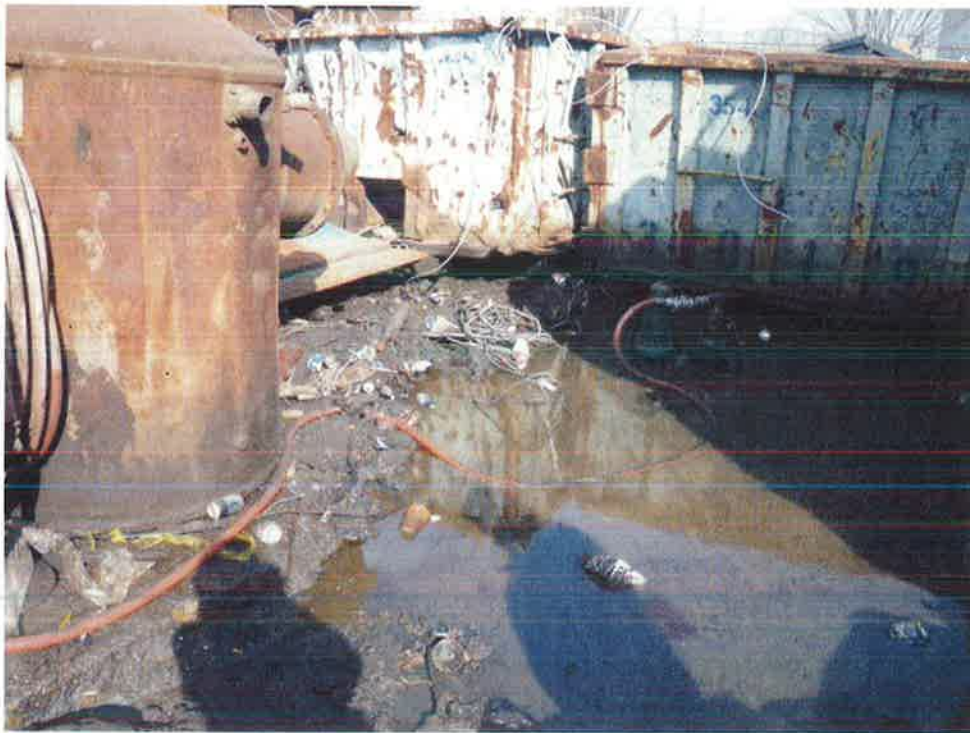
Photograph 14. Alternate view of the small runoff collection pond with the manual pump.

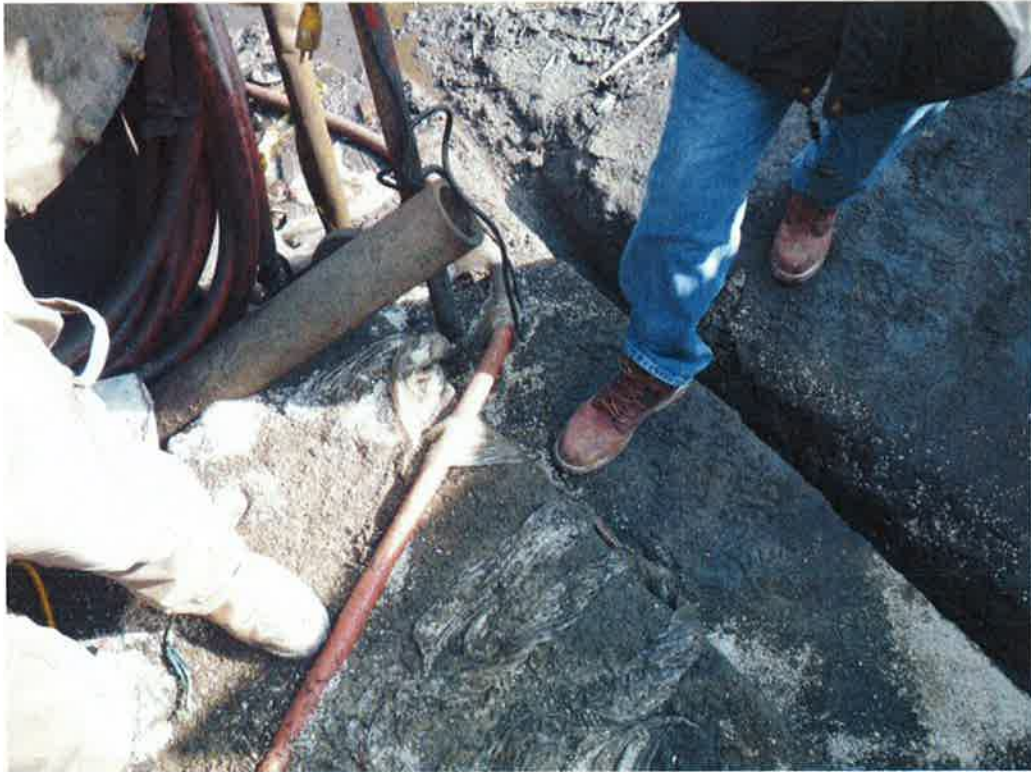
Photograph 19. **Trench leading to the small runoff collection pond.**

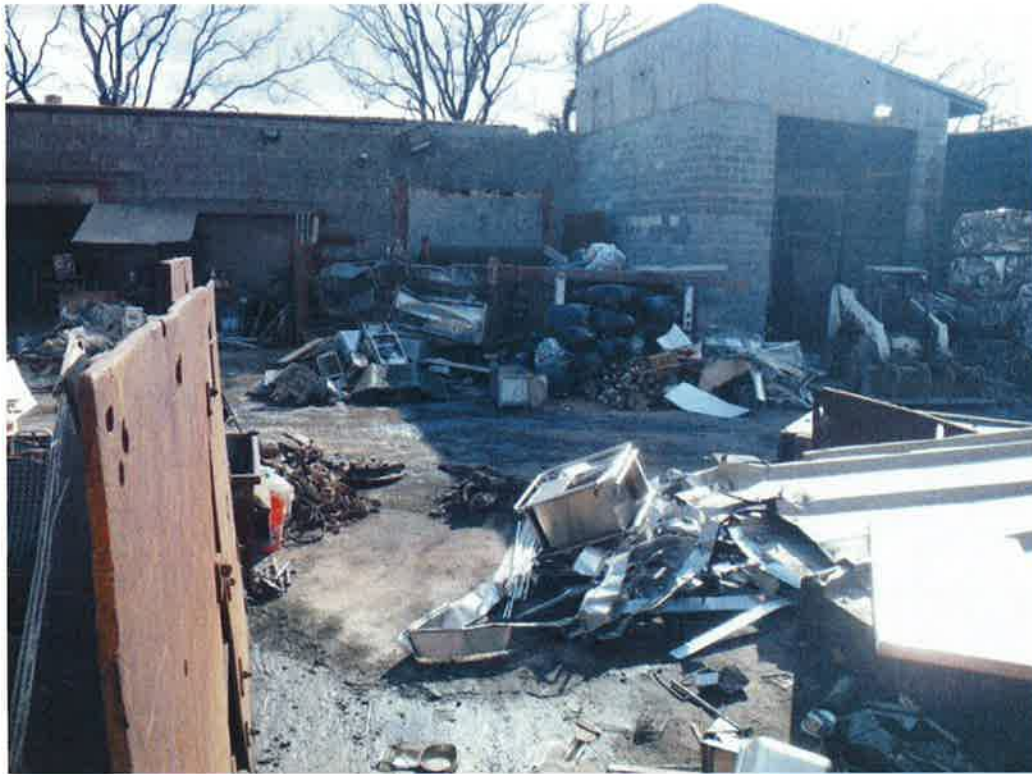
Photograph 27. Overall view of the facility from the roof of the scrap bay.

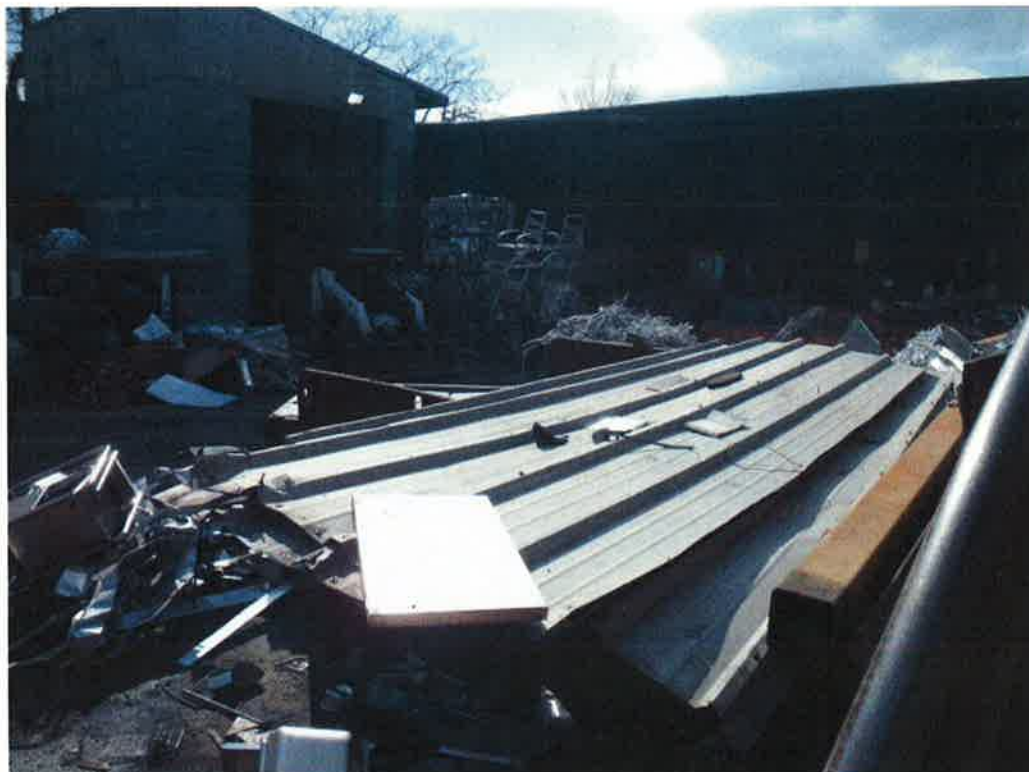
Photograph 28. Another overall view of the facility.

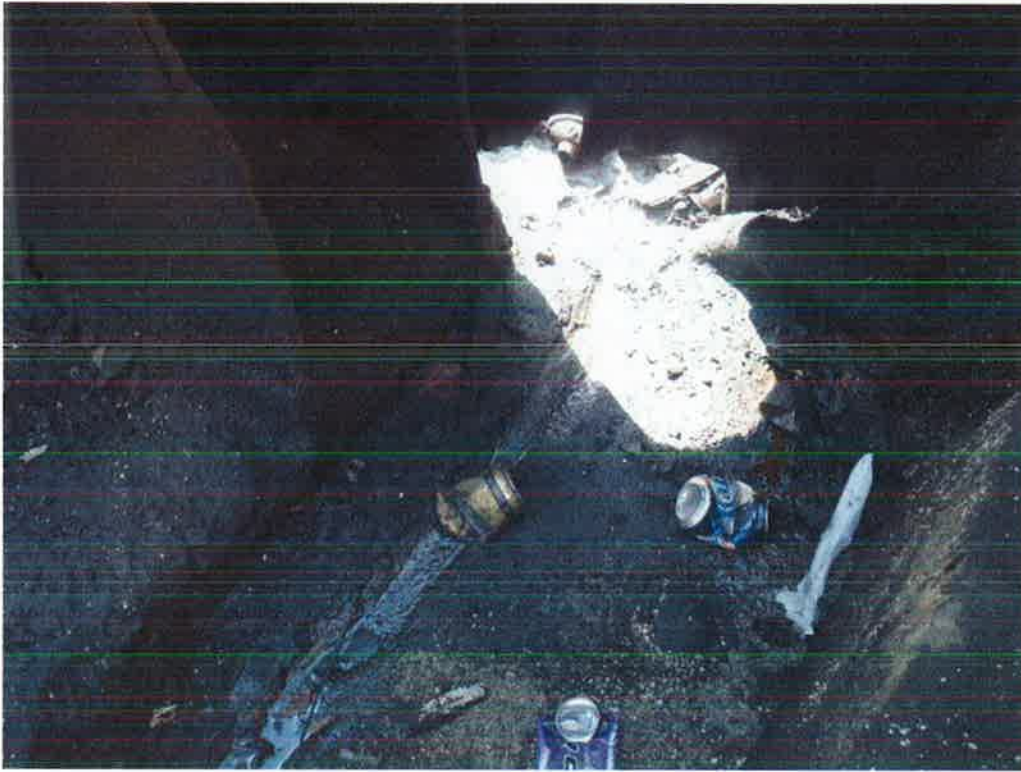
The EPA inspection team observed storage of sorted metal, engine parts, car batteries, leaking air conditioning units, and hydraulic equipment in various uncovered areas throughout the facility as well as on the property, that according to Mr. Bullock, is owned by DC (see Photographs 16, 24-28, 32-38, 41-45, 48-50, 63, and 64 in Appendix B).

Photograph 29. Entrance to the trench.

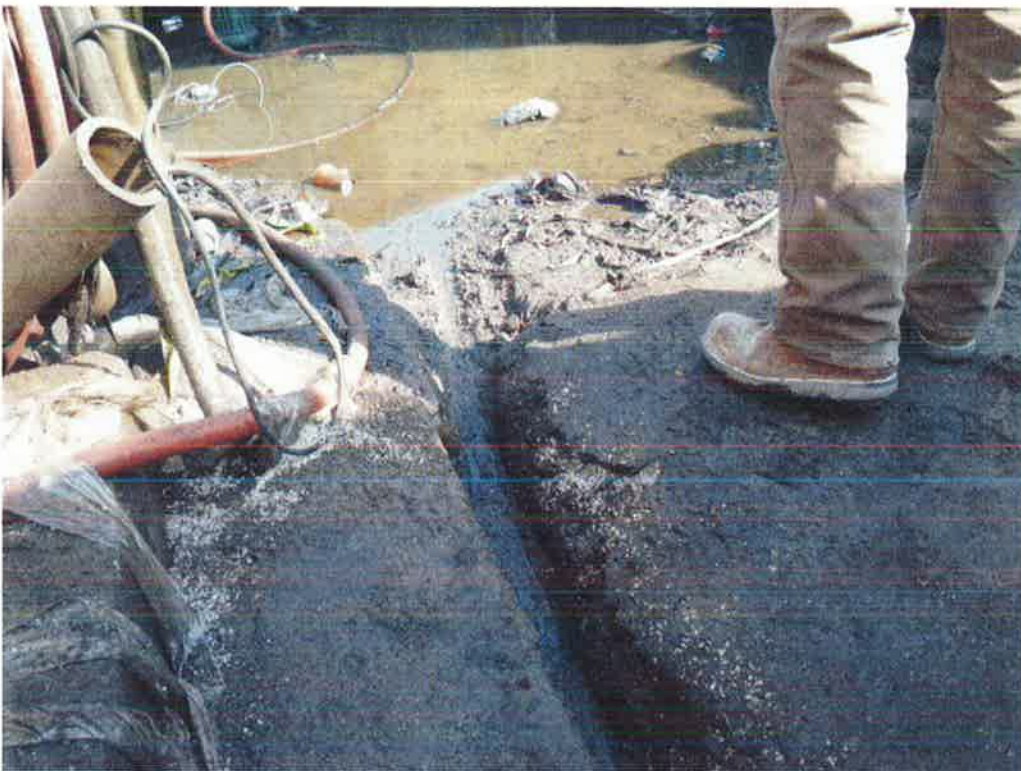
Photograph 30. The end of the trench leading into the small runoff collection pond.

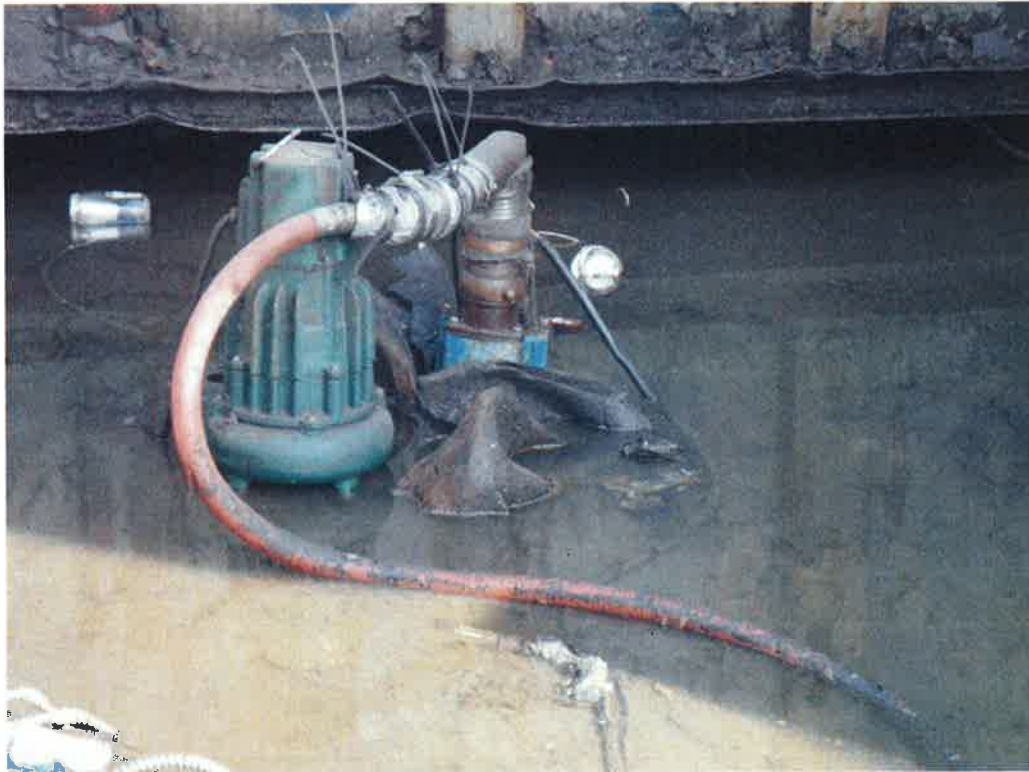
Photograph 31. Close-up view of the manual pump in the small runoff collection pond.

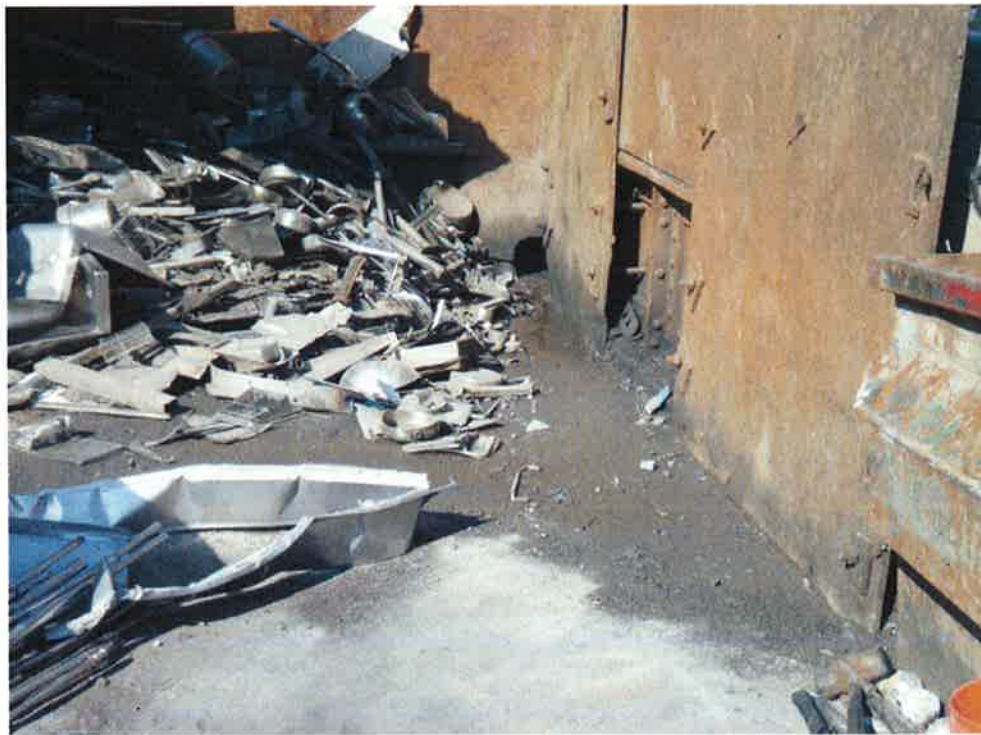
Photograph 32. Alternate view of the entrance to the trench from the opposite side of the wall shown in Photograph 30.

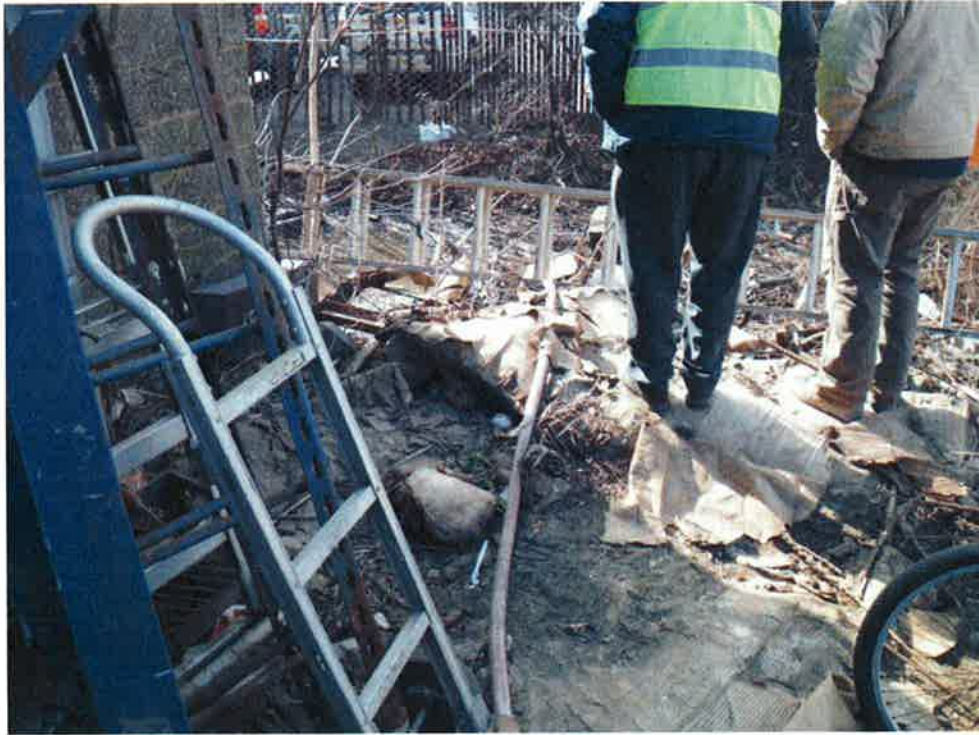
Photograph 35. Red hose leading from the manual pump in the small runoff collection pond to the large runoff collection pond.

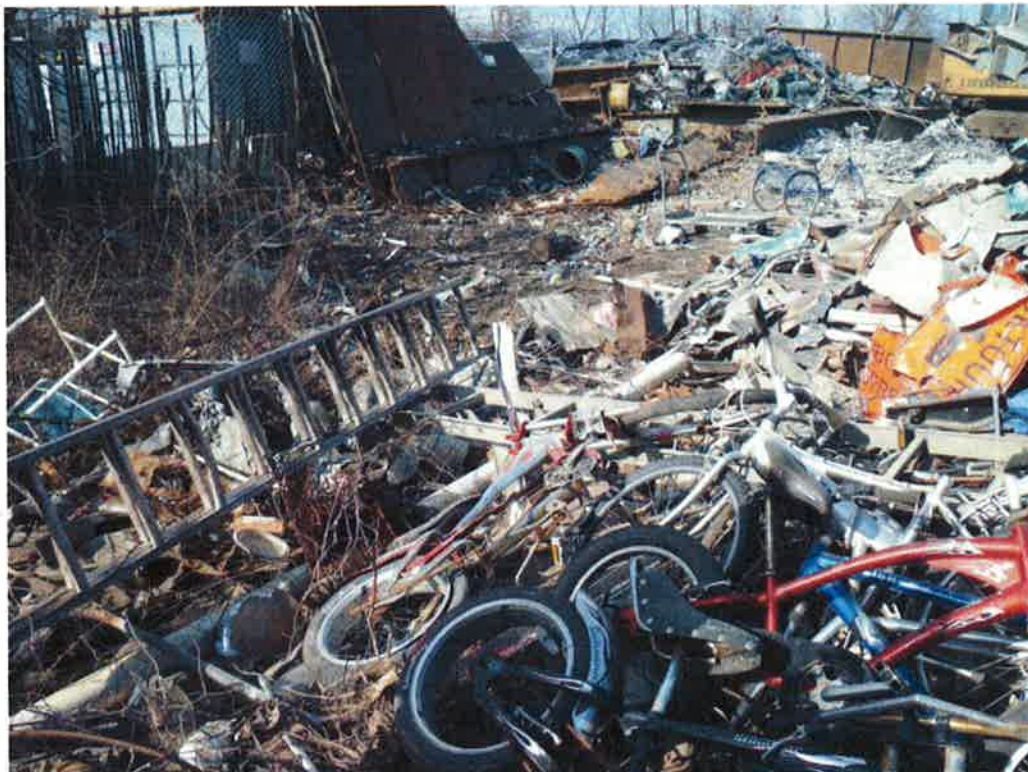
Photograph 36. View of debris just right of the large runoff collection pond.

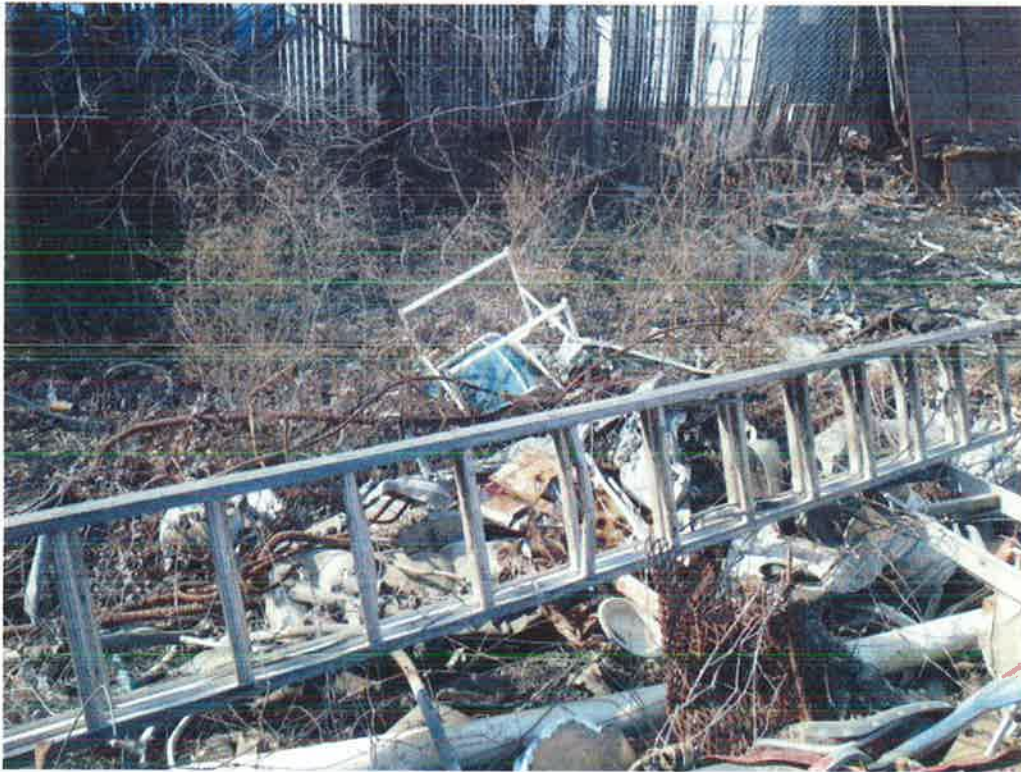
Photograph 37. **Alternate view of debris adjacent to the large runoff collection pond.**

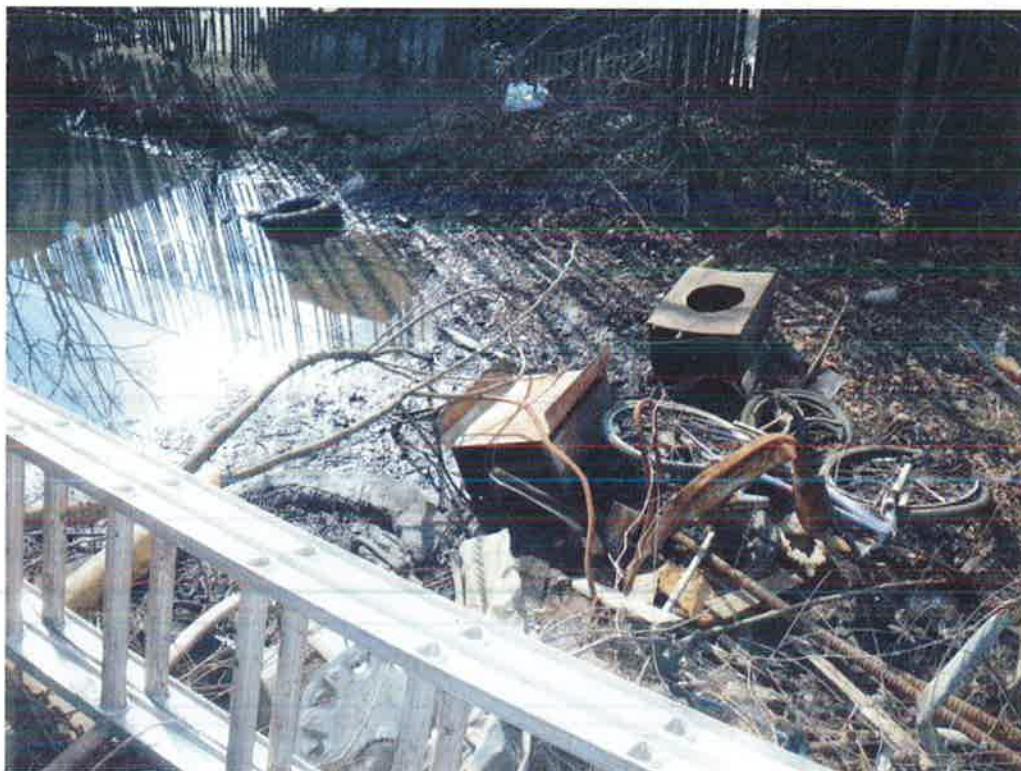
Photograph 38. **Ladder next to the northern end of the large runoff collection pond.**

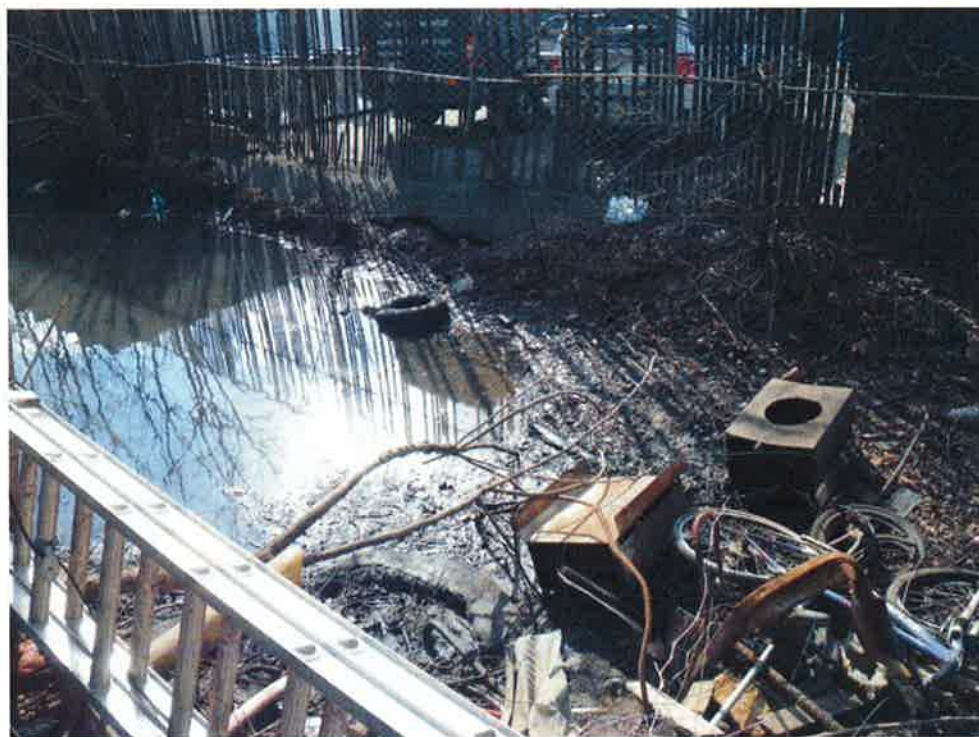
Photograph 40. Alternate view of the absorbent sock relative to the northern end of the large runoff collection pond.

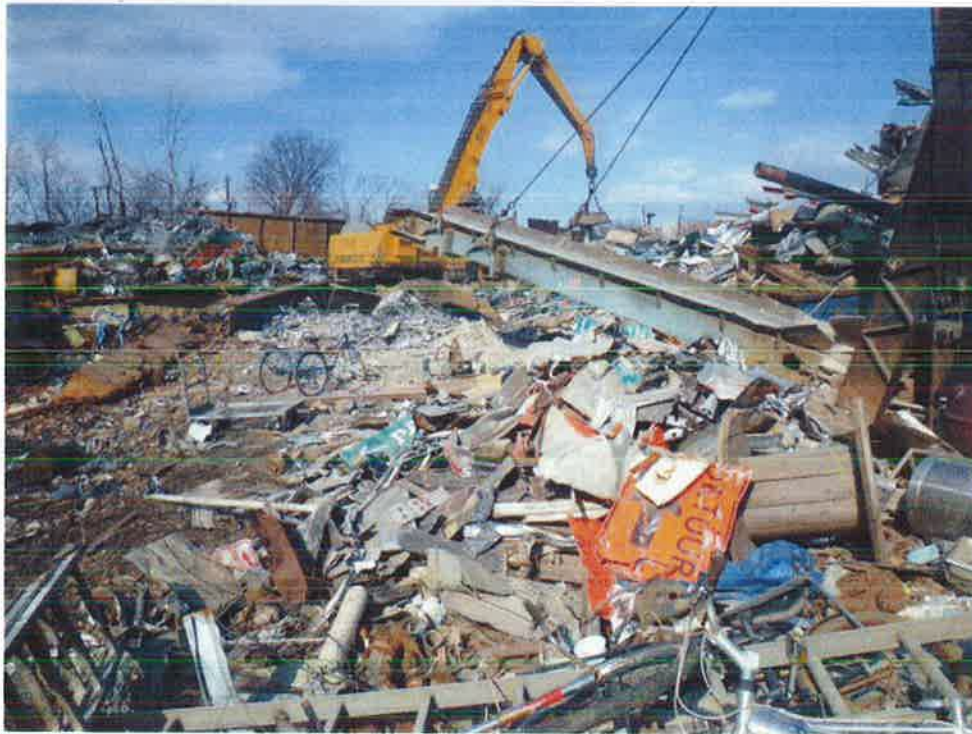
Photograph 41. Overall view of the facility from the northern end of the large runoff collection pond.

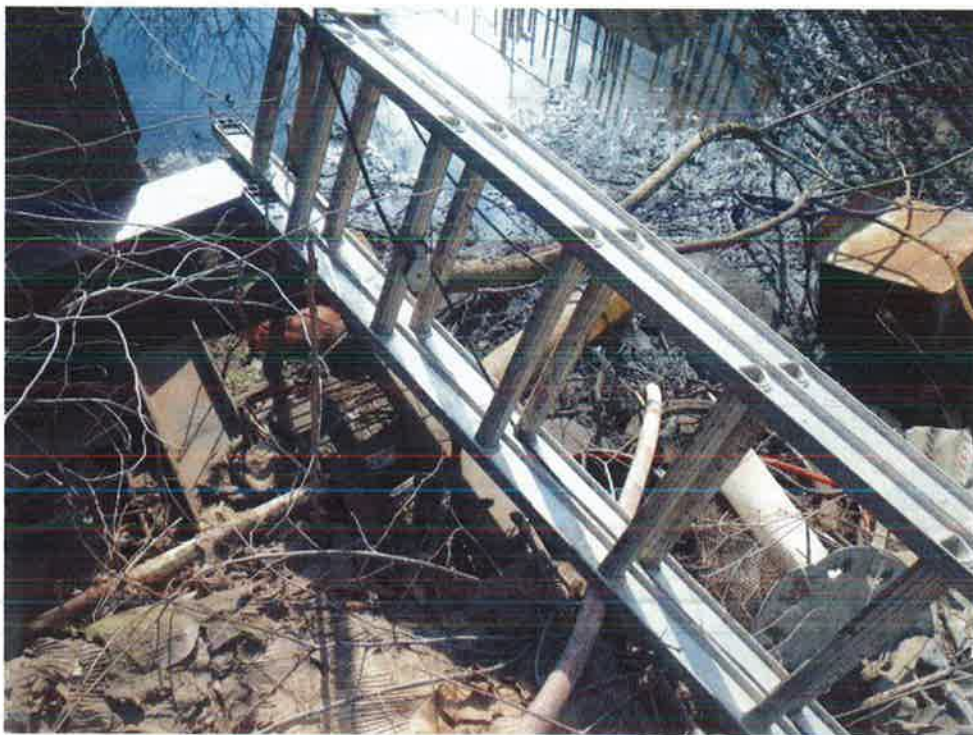
Photograph 42. Alternate view of the absorbent sock at the northern end of the large runoff collection pond.

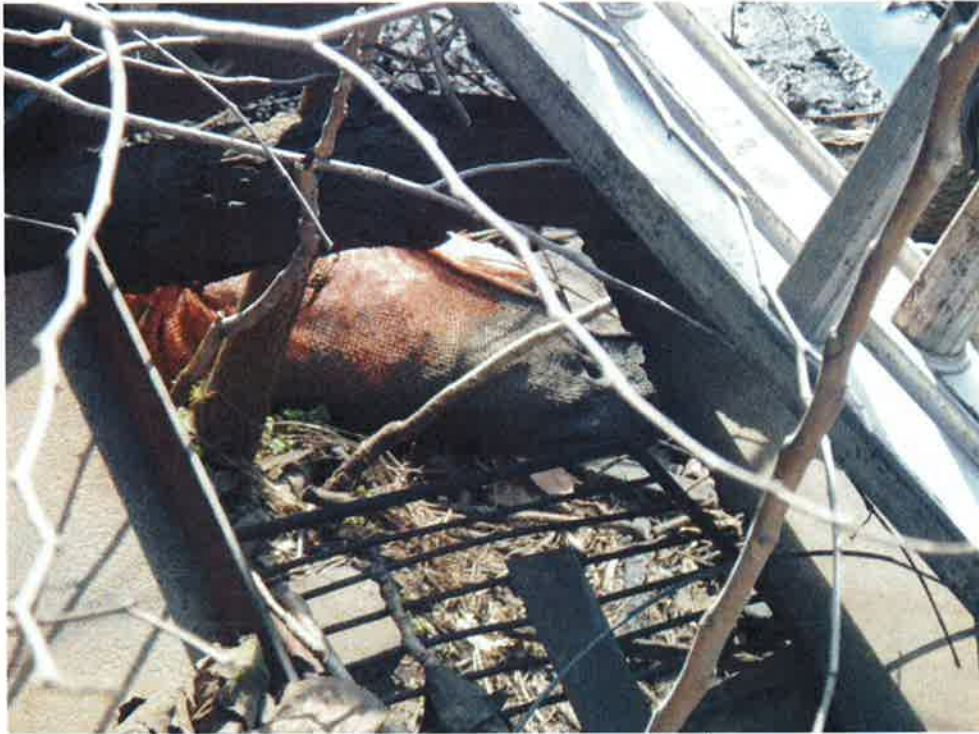
Photograph 43. Close-up view of the absorbent sock with orange indicating its original color at the northern end of the large runoff collection pond.

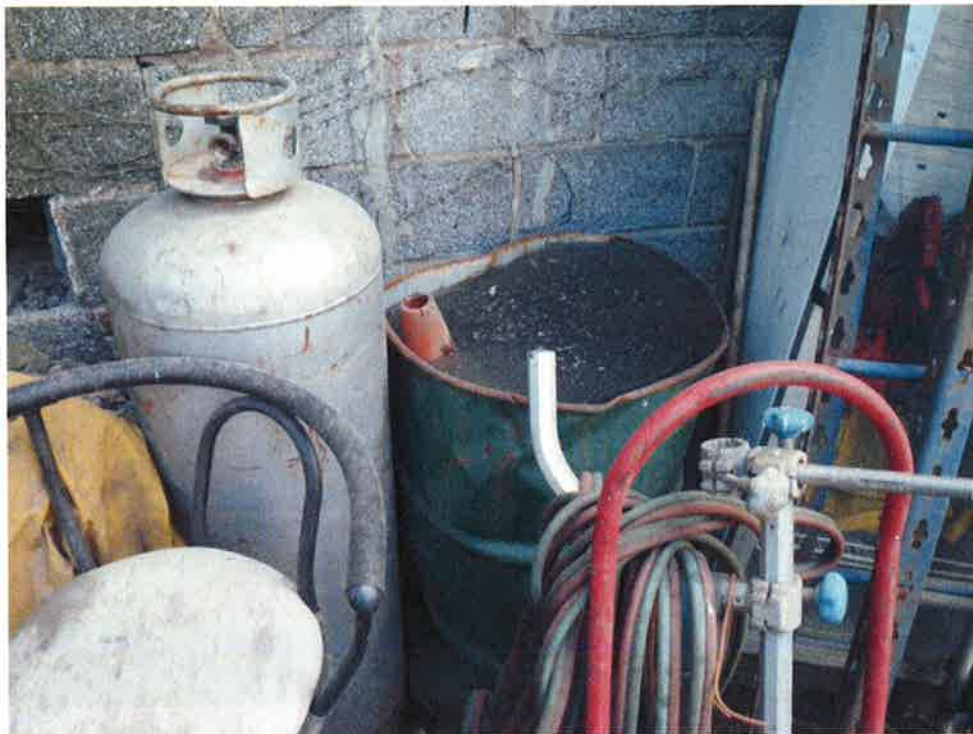
tank and numerous 55-gallon drums, without secondary containment, of what appeared to contain oils (see Photographs 34 and 44).

Photograph 44. Close-up view of a drum adjacent to the northern end of the large runoff collection pond. Note the drum is uncovered and containing a gray fluid.

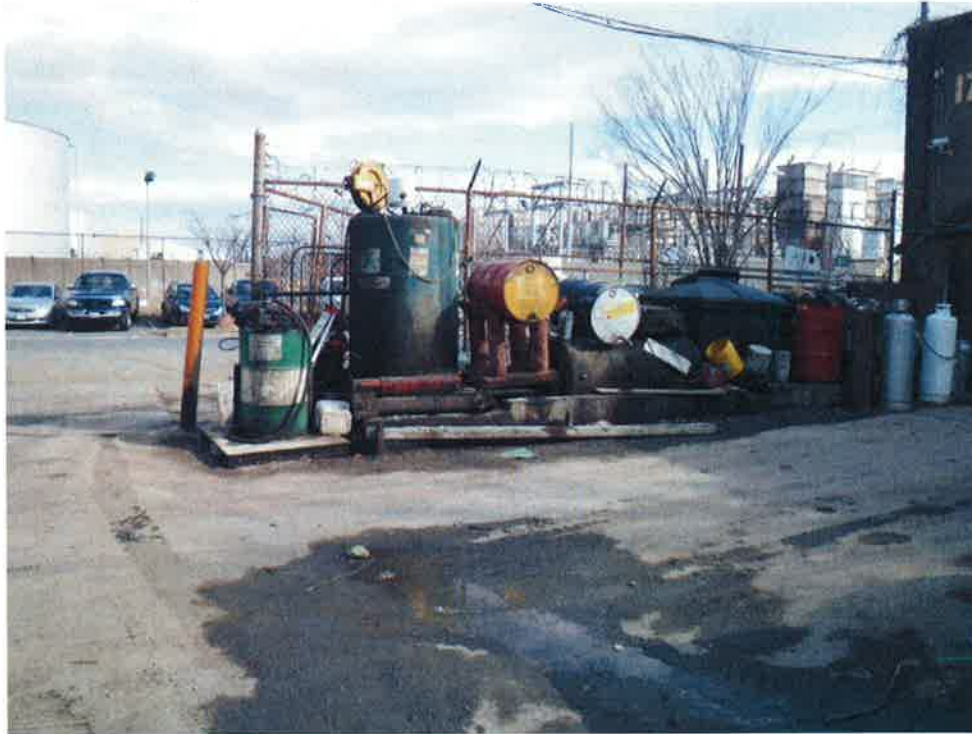
Photograph 47. Overall view of the oil drums stored near Entrance 1.

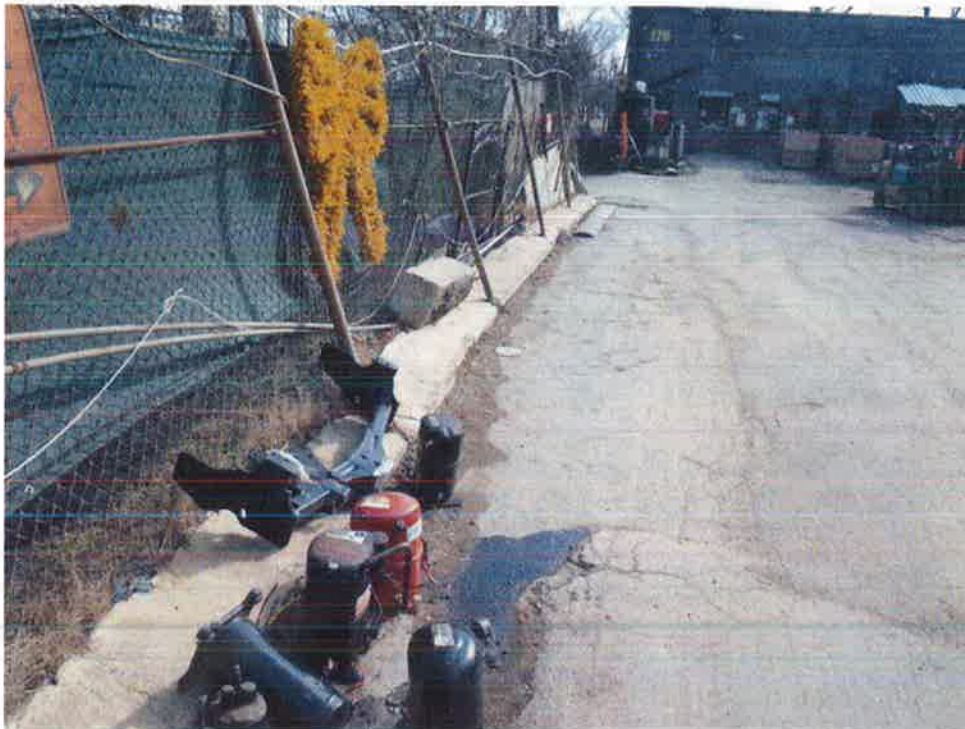
Photograph 50. View of the facility perimeter towards Entrance 1 including air conditioning units from Photograph 48.

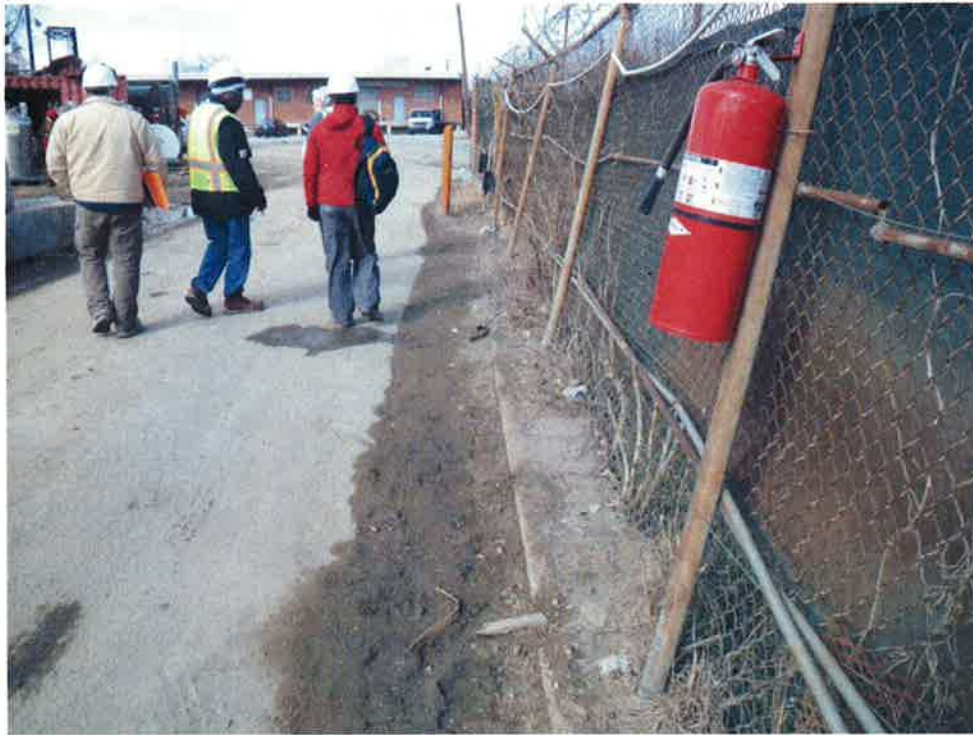
Photograph 51. **Alternate view of the perimeter towards Entrance 2.**

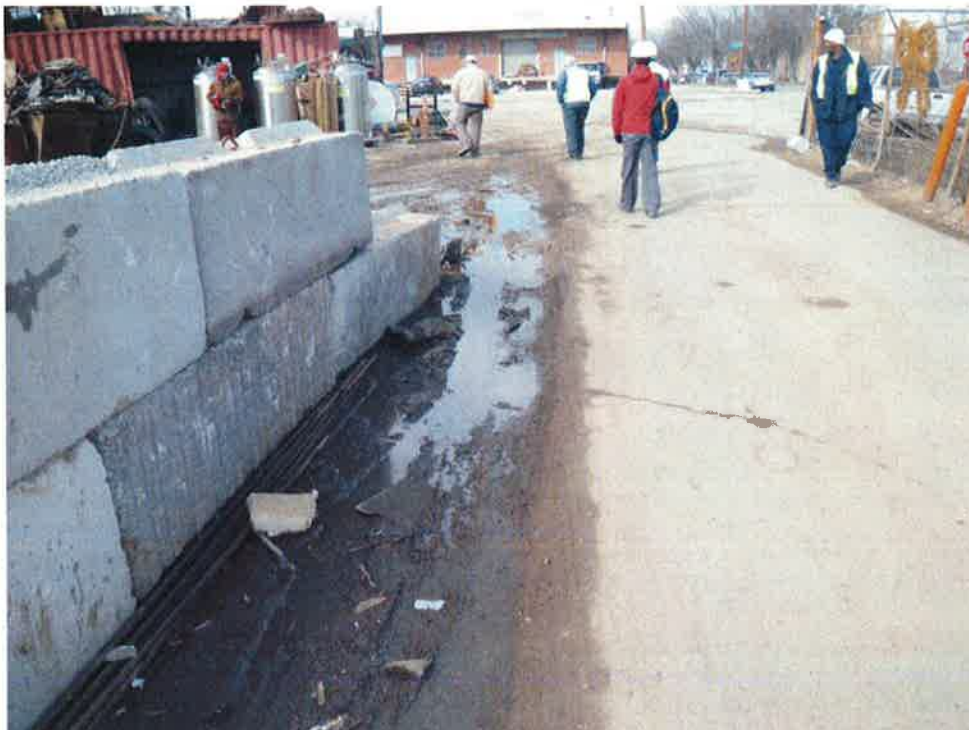
Photograph 52. **Left side of the car path looking north towards Entrance 2.**

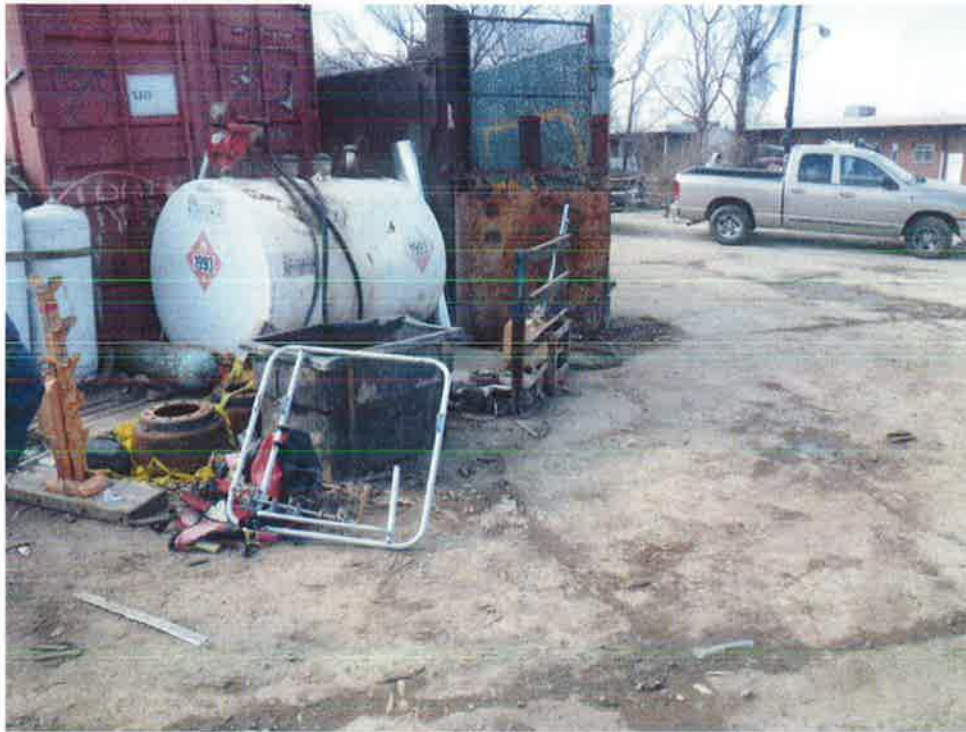
sediment entering a storm drain from the street (see Photograph 1, 53, 56, 58-64, and 79-81 in Appendix B).

Photograph 53. 500-gallon diesel tank stored by oxygen tanks near Entrance 2.

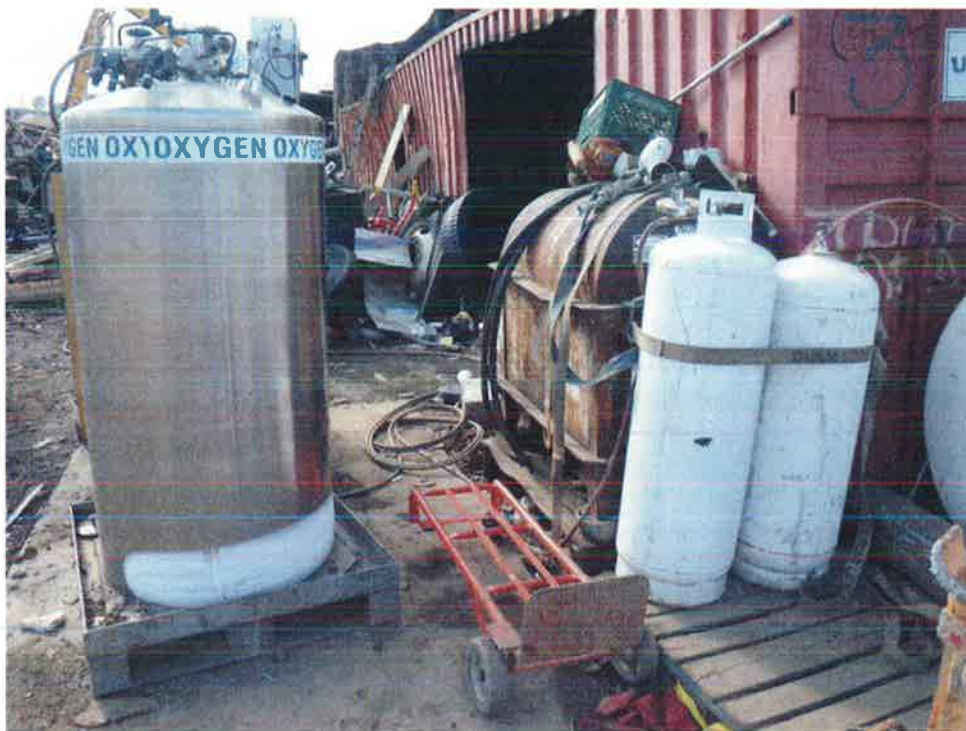
Photograph 54. Compressed gases stored near oxygen tank and fuel used for torches.

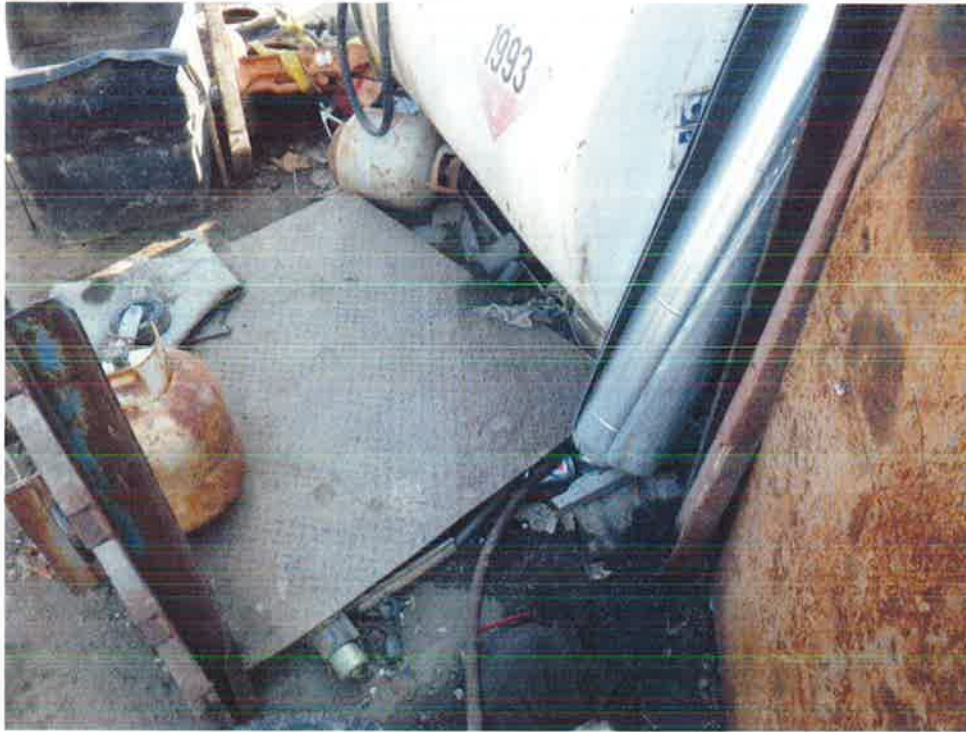
Photograph 57. Scrapped propane tanks stored near 500-gallon fuel tank.

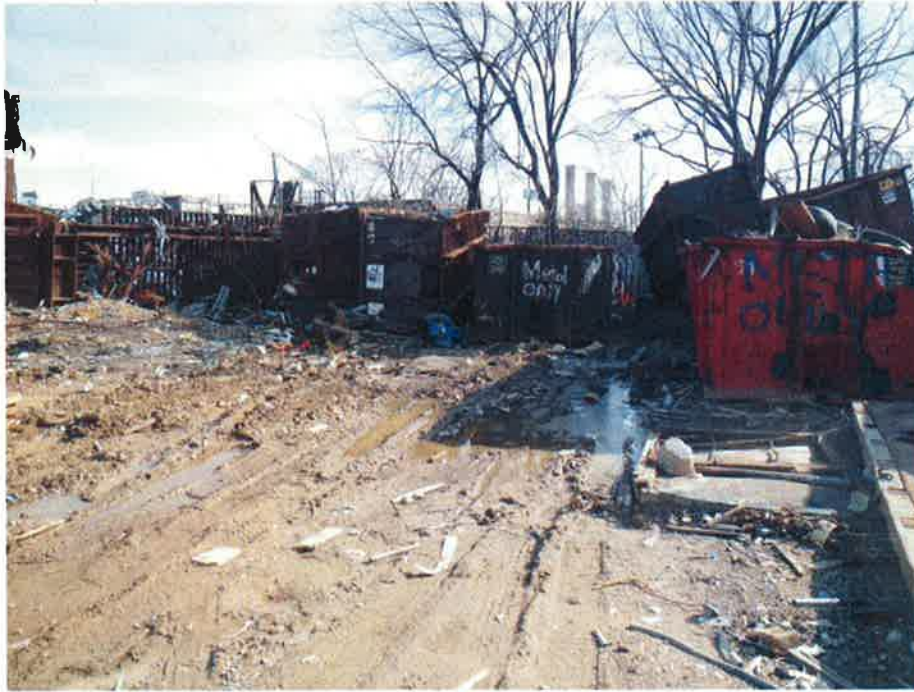
Photograph 63. Super Salvage dumpsters containing scrap stored on DC property near the Super Salvage property line. Note liquid draining from the dumpsters.
